Applies To: **1999–2000 Odyssey EX – ALL**
2001 Odyssey EX – From VIN 2HKRL18..1H500001 thru 2HKRL18..1H521371

August 7, 2001

Driver’s Seat-Back Sometimes Changes Position

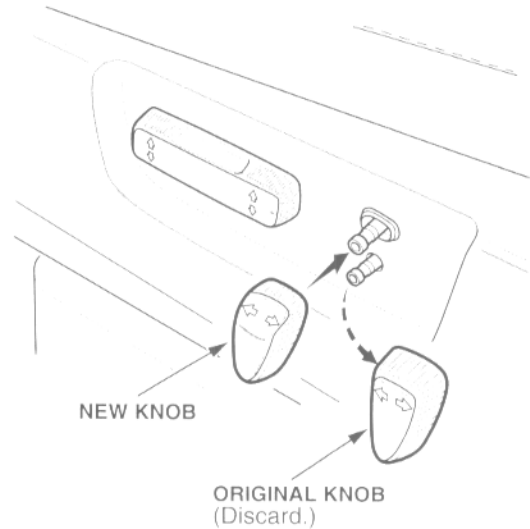
The driver’s seat recline knob is too long, allowing the driver to accidentally bump the switch with his or her thigh when entering or exiting the vehicle.

1. Remove the original knob by pulling it away from the seat.

2. Install the new knob, making sure that the forward and backward arrows are at the top.
