Applies To: **1999-01 Odyssey – ALL**
2002 Odyssey – From VIN 2HKRL18..2H500001 thru 2HKRL18..2H507787

December 11, 2001

Rear Wiper Arm Is Loose

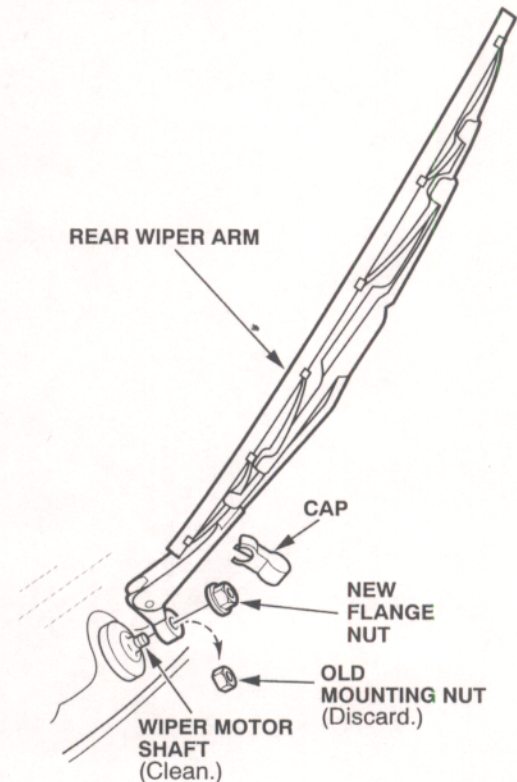
1. Remove the wiper arm cap, the nut, and the wiper arm. Discard the nut.

2. Using a wire brush, remove any wiper arm material from the splines of the wiper motor shaft.
3. Install the rear wiper arm onto the motor shaft in the park position.
4. Install the new flange nut, and torque the nut to 11.7 N·m (8.6 lb-ft).
5. Install the wiper arm cap.
6. Wet the rear window, and turn on the rear wiper to make sure it works properly.
