Applies To: 1999-02 Odyssey – ALL without Navigation System  
1998-02 Accord – ALL

## Clock Light Does Not Work (Supersedes 01-097, dated November 6, 2001)

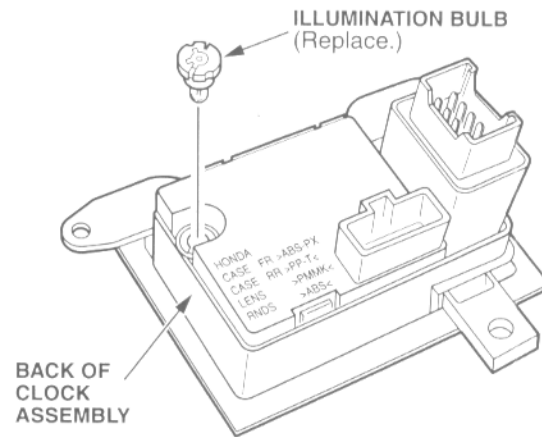
The clock does not light up with the other instrument panel lights.

1. *Odyssey:* Remove the instrument panel (see page 20-68 in the service manual). *Accord:* Remove the clock from the center panel (see page 22-129 in the service manual).
2. Replace the clock illumination bulb.

3. Reinstall the clock or the instrument panel.
4. Set the clock.
